Manhole Inspection Summary

Manhole # S23EE_014MH

Insp Date: **10/9/07 9:52 AM**

Location Address: **1316 CAREY ST**

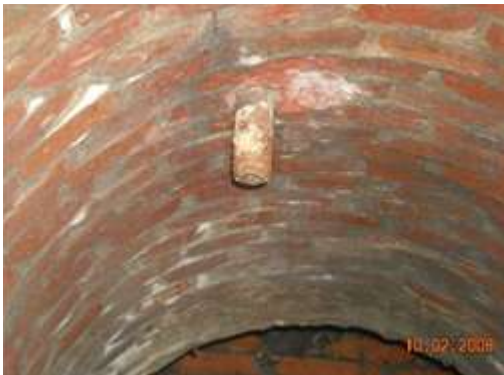
Corbel and Barrel infiltration. Channel debris.

MH valve/pipe.

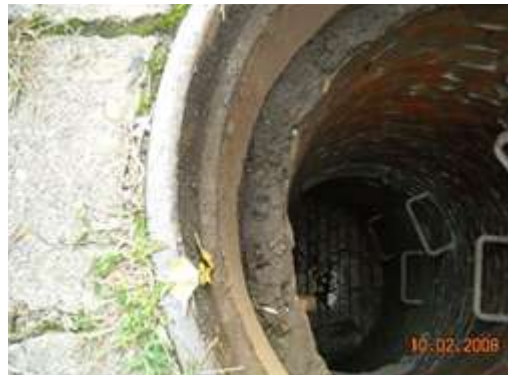
Defect

Frame leaks. Frame offset.

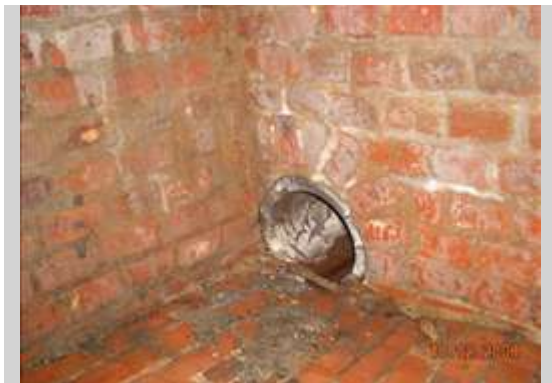
Pipe Out @ 12 O'Clock

Infiltration: **Evidence**
